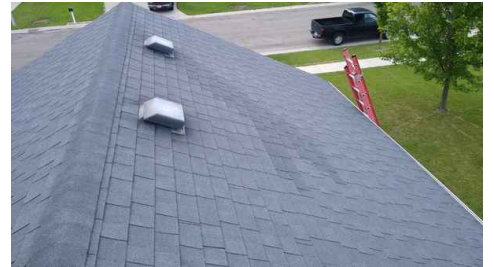
2.1.1 Coverings

DISCOLORATION

Roof shingles were discolored, which can be caused by moisture, rust or soot. Recommend a qualified roofing contractor evaluate and remedy with a roof cleaning or repair.

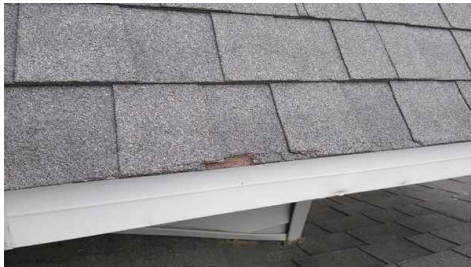
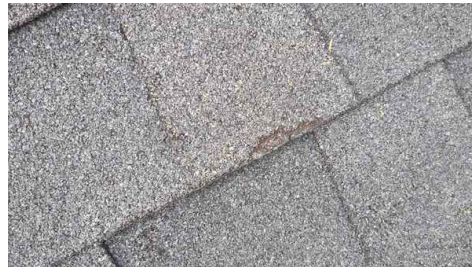
2.1.2 Coverings

SHINGLES CRACKED/BROKEN

Component: Asphalt Shingles

Condition: Cracked/Broken

Implication: Moisture intrusion and/or mold.

Location: Roof

Task: Replace Roof

Time: 2-5 yrs

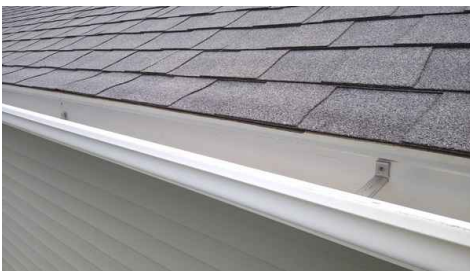
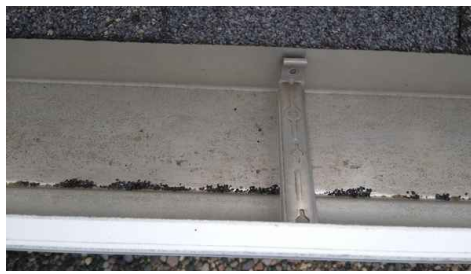
2.2.1 Roof Drainage Systems

GUTTER LOOSE

Component: Gutters

Condition: Loose/Brackets not connected in several areas

Implication: Heavy snow or rain may damage or fall off.

Location: Roof

Task: Needs to be re-fastened to fascia and pitched properly.

Time: 0-3 months

Contact a qualified gutter contractor

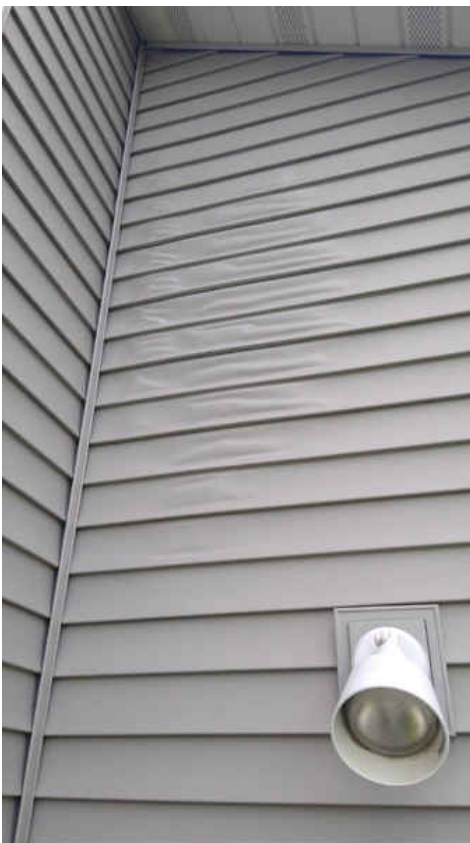
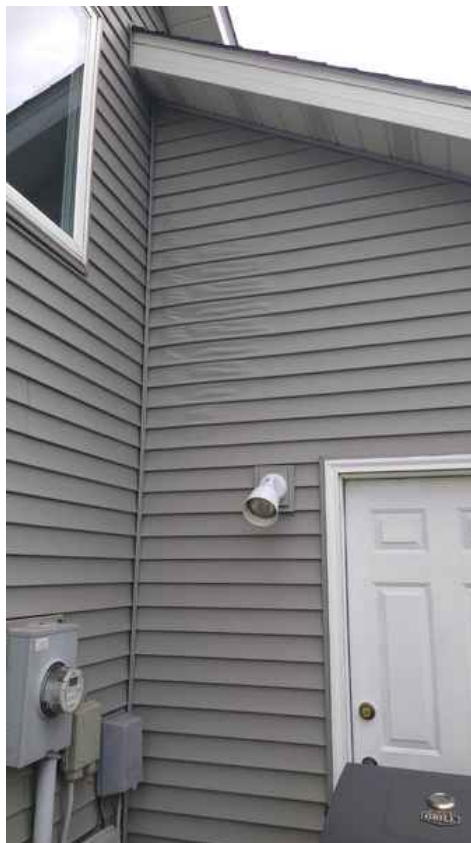
3.1.1 Siding, Flashing & Trim

DAMAGED SIDING

Component: Vinyl Siding

Condition: Warped/Melted

Implication: Chance of moisture intrusion causing damage to the home by rot/mold.

Location: Above Garage Walk-in Door

Damaged siding by Garage Walk-in Door

Task: Replace damaged siding

Time: 0-3 months

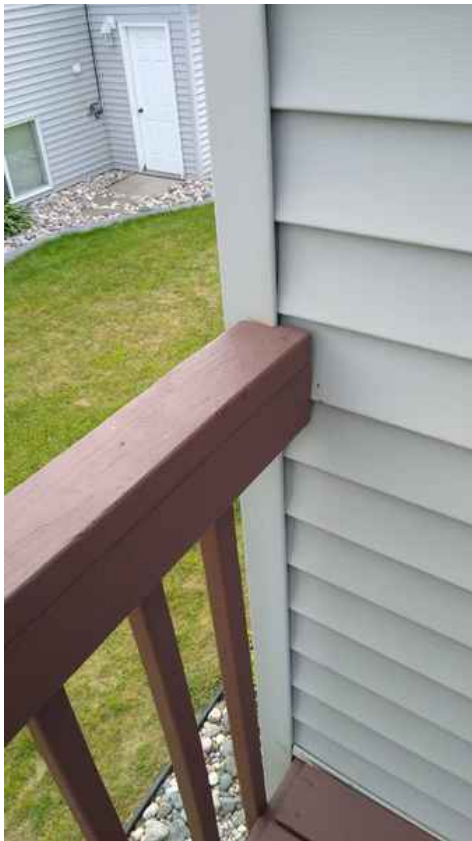
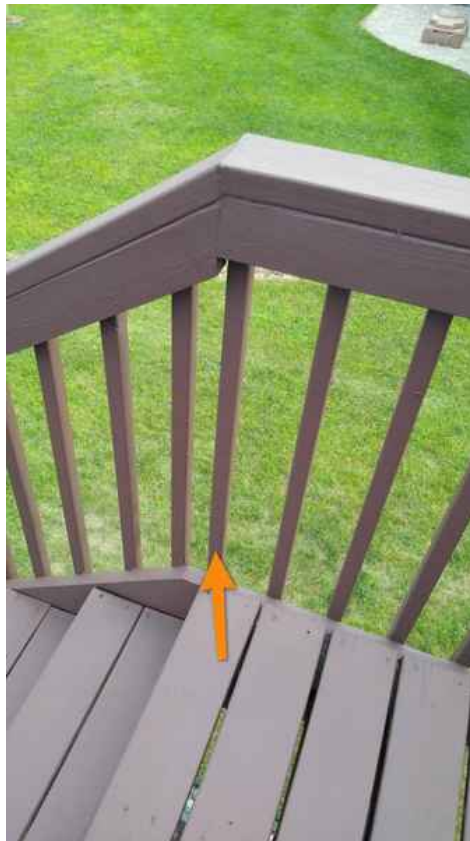
DECK RAILING WAS NOT SECURE

The railing on the south-side of the deck was wobbly and was missing a proper support. Overtime the railing could fail resulting in an injury or death. The inspector recommends that the railing gets repaired or replaced immediately.

Contact a qualified deck contractor.

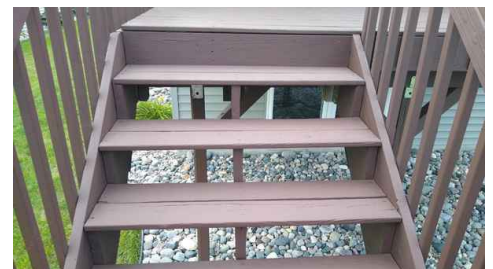
STAIR RISERS WERE OPEN

Component: Stair Risers

Condition: Open

Implication: It could allow children to trip or fall leading to a severe injury or death. Risers should have a maximum opening of 4" to prevent a child from going through the opening.

Location: Deck

Task: Add in boards to seal risers

Time: Immediate

Contact a qualified professional.

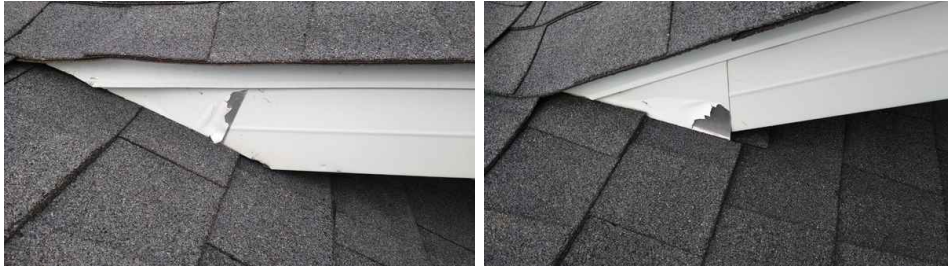
3.5.1 Eaves, Soffits & Fascia

PAINT/FINISH FAILING

Component: Fascia

Condition: Paint was peeling in some areas

Implication: Looks aesthetically unpleasing

Location: Roof

Task: Repaint

Time: 0-3 months

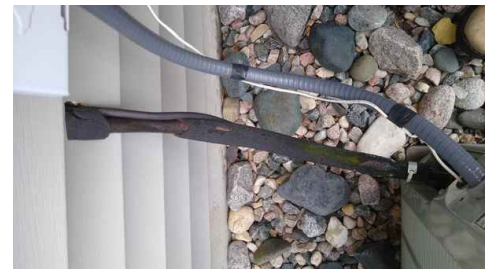
6.1.1 Cooling Equipment

INSULATION MISSING OR DAMAGED

Component: Refrigerant line on A/C unite

Condition: Missing or damaged insulation

Implication: Can cause energy loss and condensation.

Location: North side

Task: Install new insulation

Time: 0-2 months

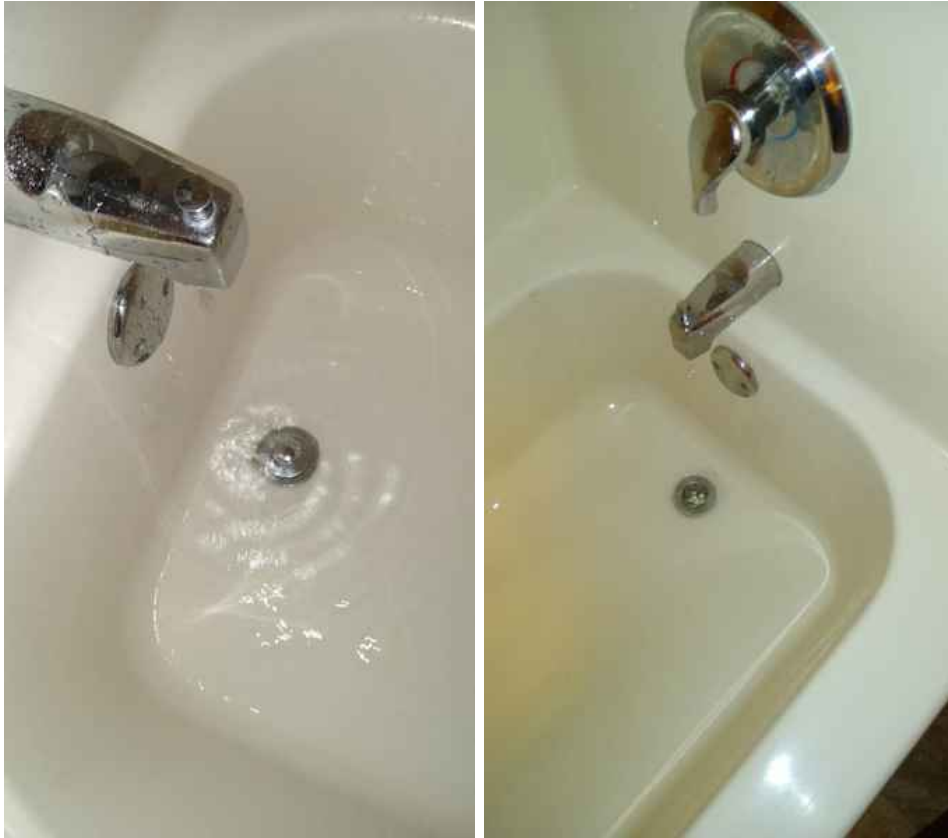
7.2.1 Drain, Waste, & Vent Systems

SHOWERS/TUBS/TOILETS - POOR DRAINAGE

Component: Tubs/Showers/Toilets

Condition: Slow draining

Implication: Could backup or not drain at all

Location: Bathrooms

Showers had slow/poor drainage. Recommend a qualified plumber repair and scope.

Task: Have licensed plumber scope and clean all waste lines, including main.

Time: Before Closing

Contact a qualified plumbing contractor.

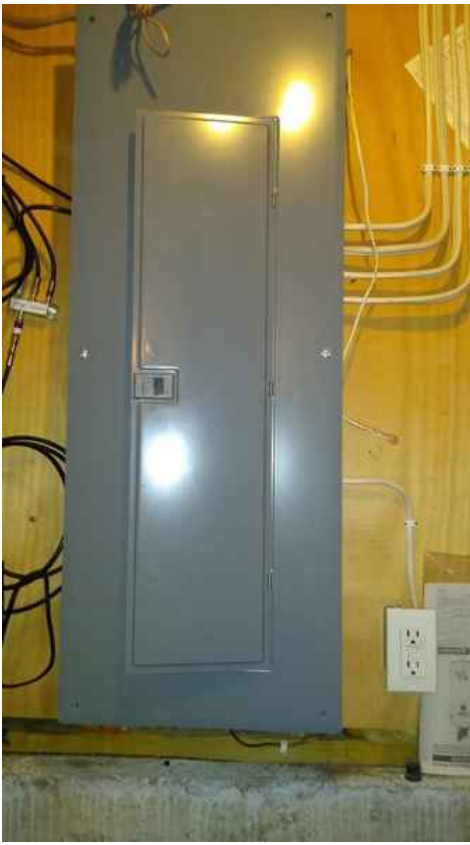
8.2.1 Main & Subpanels, Service & Grounding, Main
Overcurrent Device

MISSING SCREWS

Component: Main Electrical Service Panel

Condition: Missing Screws

Implication: A panel without proper screws can be a safety hazard

Location: Basement Utility room

Task: Install proper screws

Time: Immediate

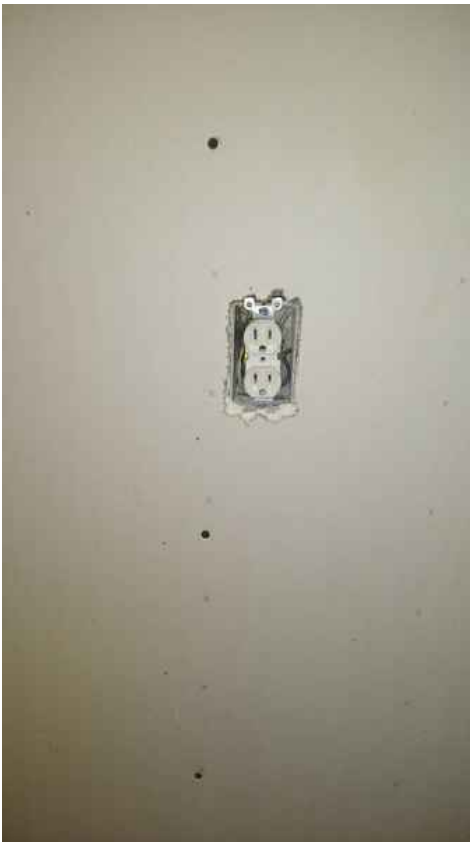
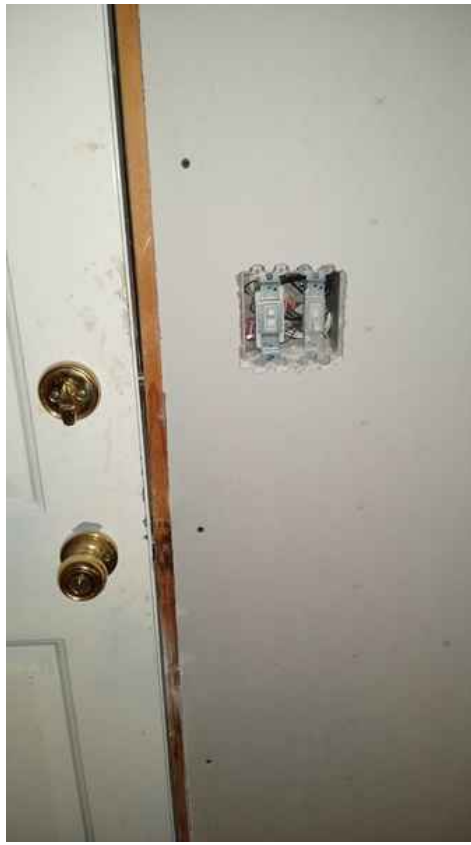
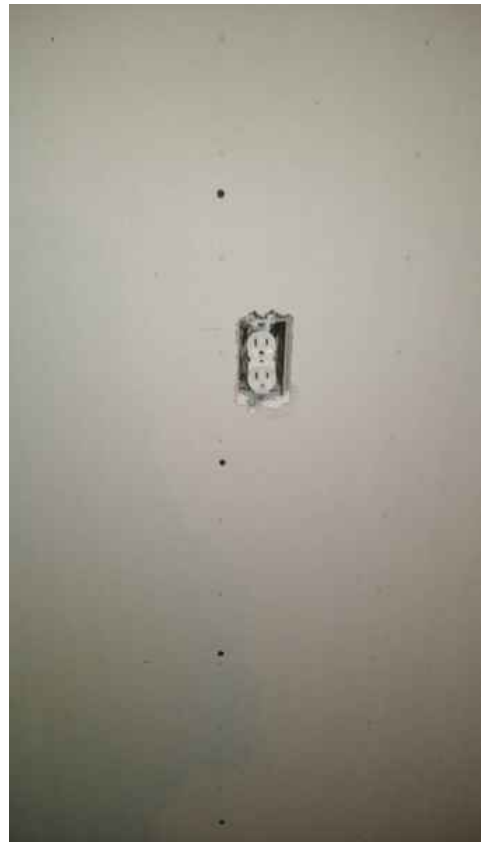
8.4.1 Lighting Fixtures, Switches & Receptacles

COVER PLATES MISSING

Component: Electrical Receptacle/Switches

Condition: Cover plates are missing

Implication: Electrocutation Hazard

Location: Garage

Task: Install cover plates

Time: Immediate

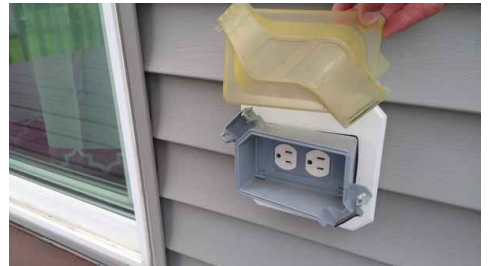
8.4.2 Lighting Fixtures, Switches & Receptacles

BROKEN COVER

Component: Electrical Receptacle

Condition: Broken Cover

Implication: Electrocution Hazard

Location: By sliding door

Broken Cover

Task: Install new cover

Time: Immediate

Contact a qualified professional.

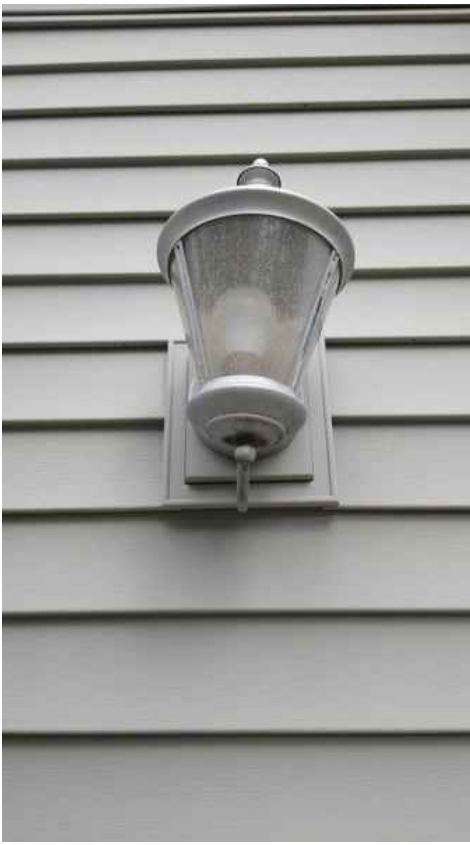
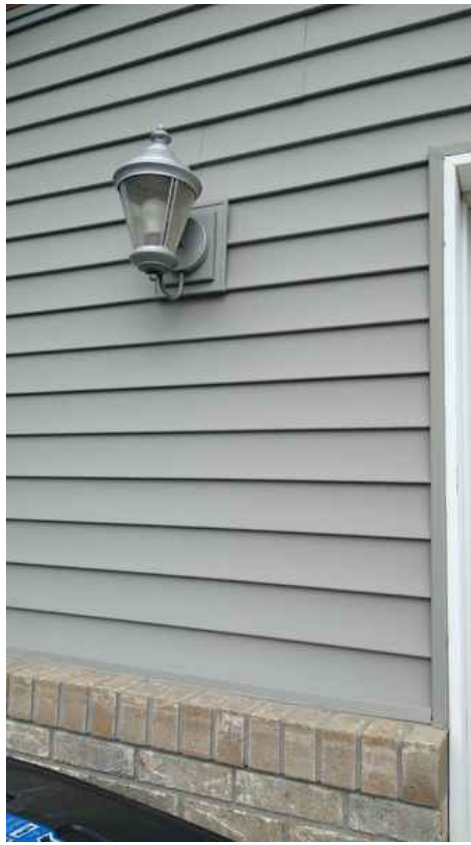
8.4.3 Lighting Fixtures, Switches & Receptacles

LOOSE LIGHT FIXTURE

Component: Exterior Light fixtures

Condition: Loose

Implication: May fall off

Location: Exterior of Garage

Task: Tighten light fixture

Time: Immediate

Contact a qualified electrical contractor.

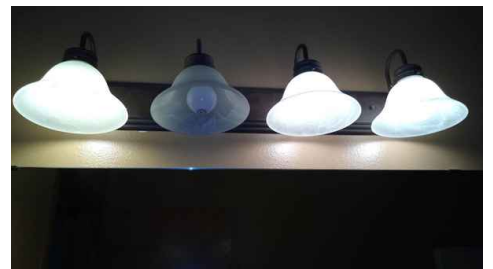
8.4.4 Lighting Fixtures, Switches & Receptacles

LIGHT BULB NOT WORKING

Component: Light Bulb

Condition: Not working

Implication: Low light

Location: Bathroom

Task: Replace light bulb

Time: Immediate

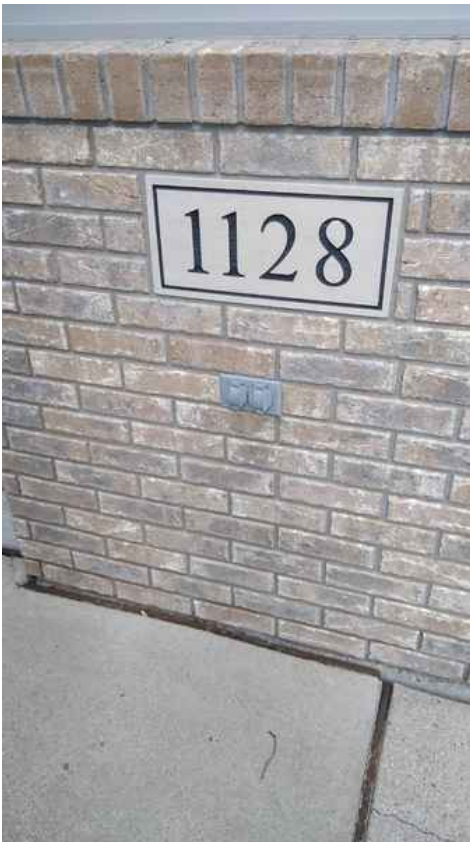
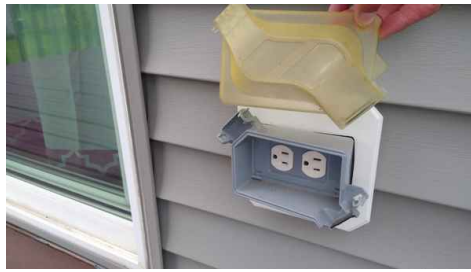
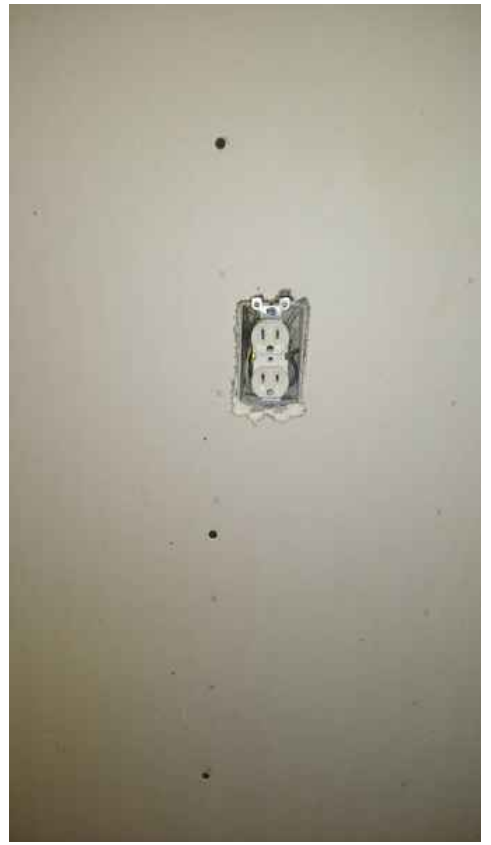
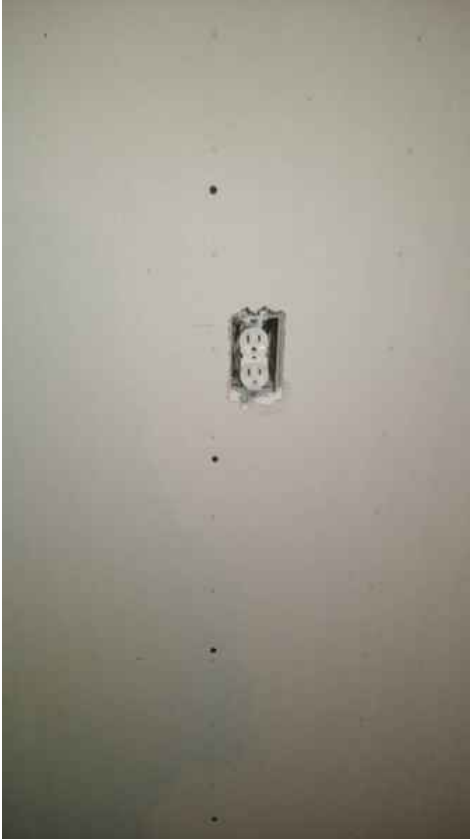
8.5.1 GFCI & AFCI

NO GFCI PROTECTION INSTALLED

Component: Electrical Outlets

Condition: Missing GFCI Protection

Implication: Short or electrical shock risk

Location: Exterior, Kitchen, Bathrooms, Garage

Task: Have licensed electrician upgrade by installing ground fault receptacles.

Time: Immediate

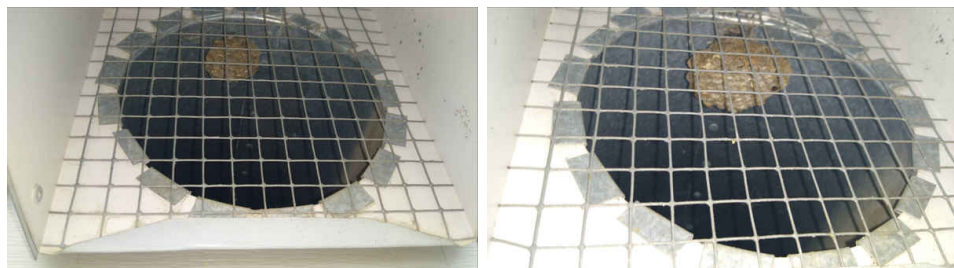
9.3.1 Ventilation

HORNET NESTS IN AIR EXCHANGE VENTS

EAST SIDE

Component: Intake & Exhaust vents

Condition: Hornet nests were located inside of the intake and exhaust vents for the air exchange system.

Implication: The hornets could enter the house via the duct work or fly around in the backyard.

Location: East Side (Back of house)

Task: Remove the hornet nests

Time: Immediate

Contact a qualified pest control specialist.

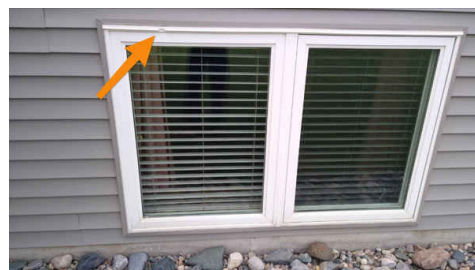
10.2.1 Windows

DAMAGED

Component: Window

Condition: Damaged drip edge

Implication: Moisture intrusion and/or mold.

Location: Backside of house

Task: Repair drip edge

Time: 0-3 months

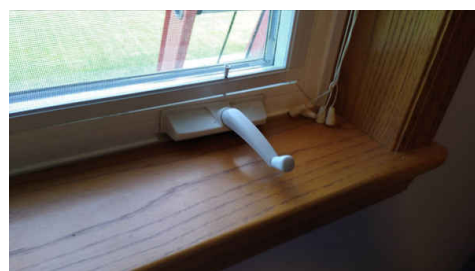
10.2.2 Windows

BROKEN MECHANISM

Component: Window Crank

Condition: Broken Mechanism

Implication: Energy loss, Moisture intrusion and/or mold.

Location: Upstairs second bedroom

The window in the second upstairs bedroom had a broken mechanism that would not allow it to close. Recommend replacing the mechanism.

Task: Replace mechanism

Time: Immediate

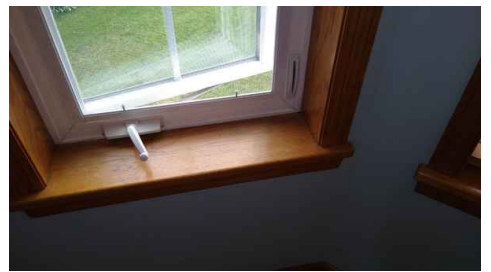
10.2.3 Windows

WINDOW MISSING/BROKEN LATCH

Component: Window

Condition: Missing latch

Implication: Energy loss, moisture intrusion and/or mold.

Location: Left window in living room

*The window in the living room on the left side was missing a latch. By not having an operable locking latch, the window can not stay closed which may allow wind or hot/cold air to continually enter the home. Recommend installing a new closing/lock latch on the casement window.

Task: Install new latch/window

Time: Immediate

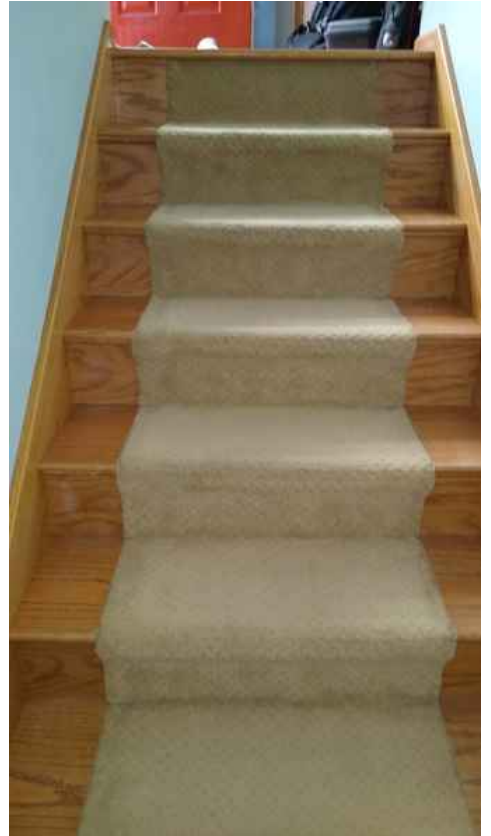
10.3.1 Floors

MODERATE WEAR

Floors in the home exhibited moderate surface wear along major paths of travel. Recommend a qualified flooring contractor evaluate for possible re-finish.

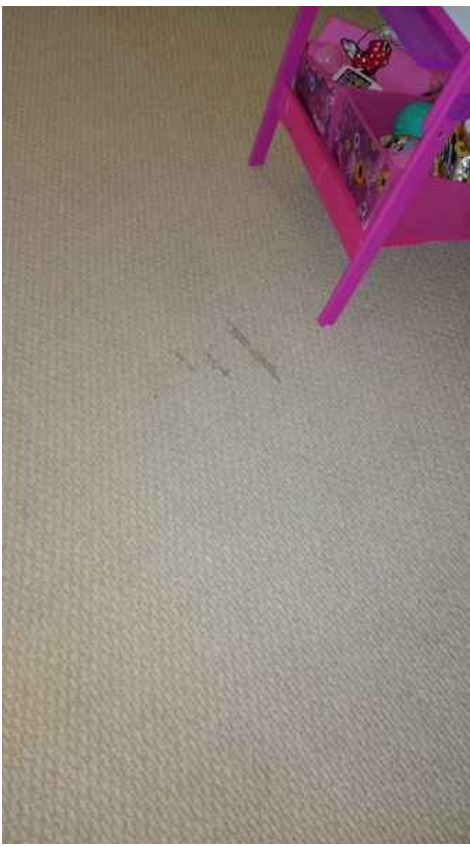
10.3.2 Floors

CARPET HAD DAMAGE

Component: Carpet

Condition: Damaged

Implication: Trip hazard

Location: Basement living

Task: Replace floor covering

Time: 0-3 months

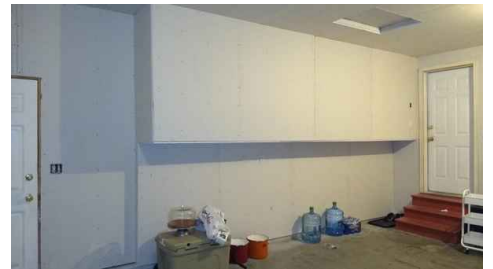
10.4.1 Walls

SEAMS NOT SEALED

Component: Drywall

Condition: Seams not taped

Implication: Carbon Monoxide and other fumes could leak into the living space causing harm or possible death.

Location: Garage

Task: Tape and mud drywall seams and screws on interior walls of garage

Time: 0-3 months

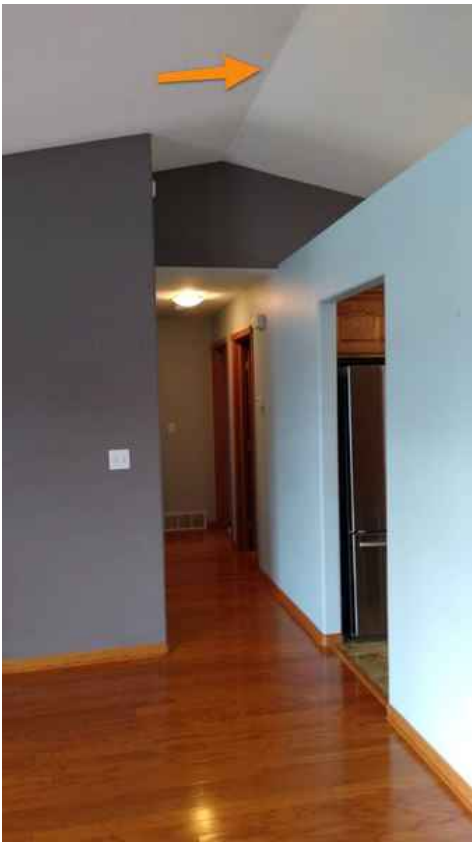
10.5.1 Ceilings

DRYWALL TAPE LOOSE

Component: Drywall Tape

Condition: Loose

Implication: Aesthetically displeasing

Location: Living Room Vaulted Ceiling

Task: Have drywall company repair/replace

Time: 0-3 months
